#### DEPARTMENT OF TRANSPORTATION

## WELDING INSPECTION REPORT

**Project Name:** SAS Superstructure **OSM Arrival Time:** 1500 **OSM Departure Time:** 300 **Prime Contractor:** American Bridge/Fluor Enterprises, a JV

34-0006 **Bridge No: Component:** BAY 14 OBG

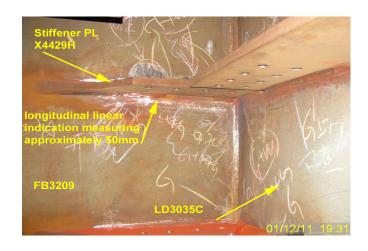
This QA observed one longitudinal indication in weld identified as FB3209-001-115 that did not appear to comply with the contract documents. This QA informed ZPMC QC identified as Mr. Wang Lu and ABF QA inspector identified as Peter Shaw of this issue and that an incident report would be generated concerning this issue. For further details, refer to the incident report issued by this QA on this date and the attached photos
